# Technical Booklet

**LG Electronics Alabama, Inc.**  
**2023. 10**

# Refrigerator SVC Bulletins

## Frost around freezer fan motor

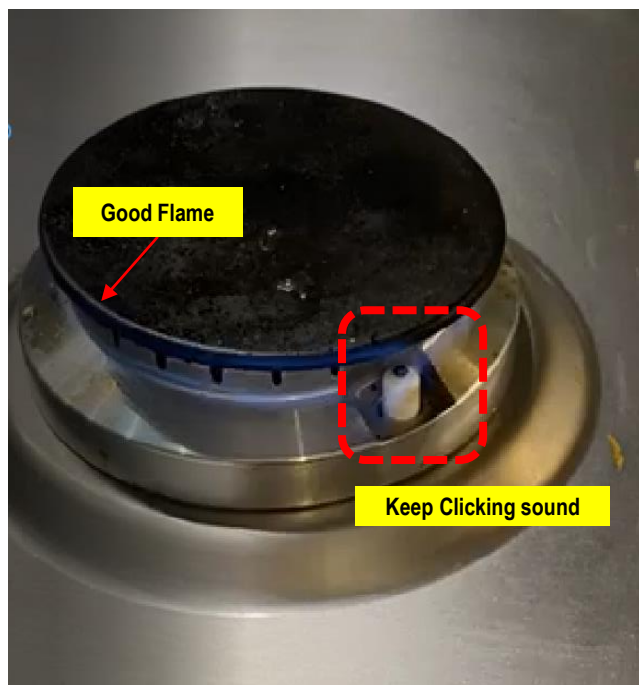
### Issue Symptom

**Keep attempting to ignite with clicking sound even with good flame**

Cause #1: Re-ignitor is defective itself

Cause #2: Voltage Problem → Should be 120V between Live and Neutral, 120V between Live and Ground.

Cause #3: Check positioning of the Spark Plug and Burner Assembly.

Cause #4: Simmer flame is too small → If there is a problem with the nozzle or valve, the gas flow may be abnormally low.

Cause #5: Severe flame fluctuation → a faulty flame sensor.

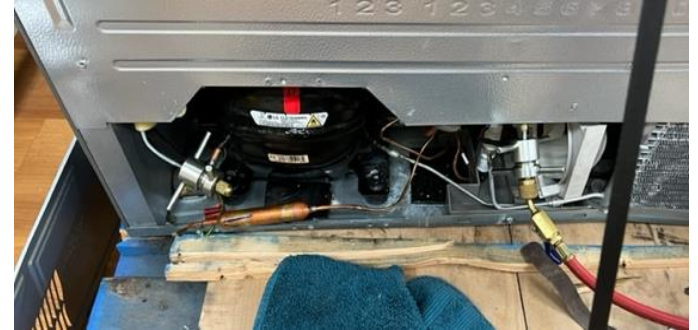
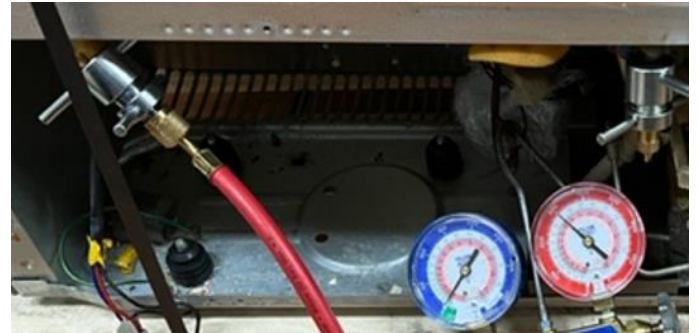
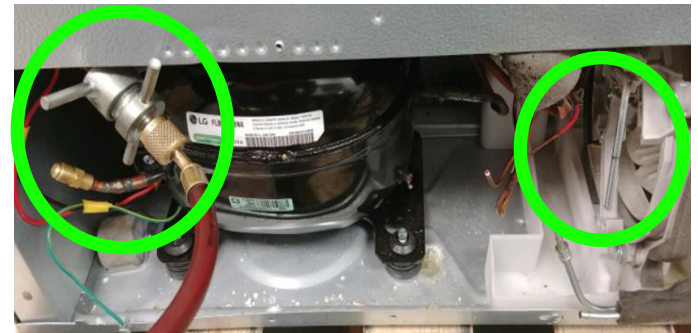
Right side are examples of Proper isolations and what will be expected to be seen by the TCC agent when running telepresence.

- Yoder needs to be fully isolated by itself. This means removing the drier and cutting the yoder loose on the condenser side above the factory connection.
- Close off one side of the yoder loop.
- Attach one gauge to the other side of the yoder loop. There is no need to hook up gauges to both sides of the yoder, this increases your chances of equipment failure mimicking a yoder leak.

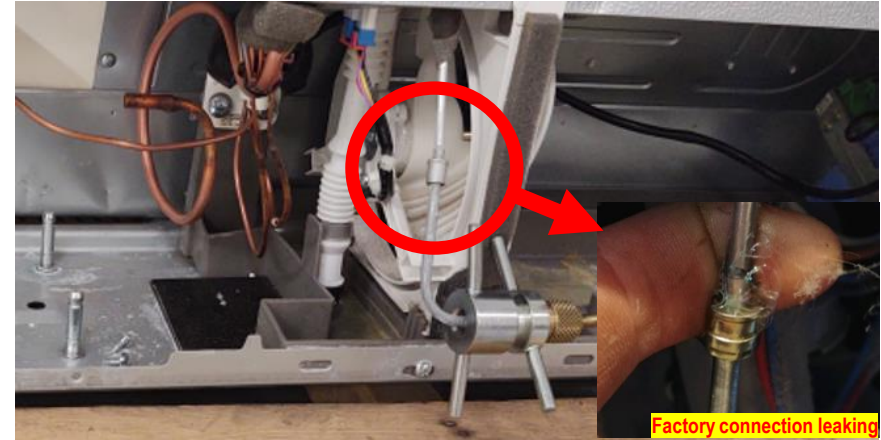
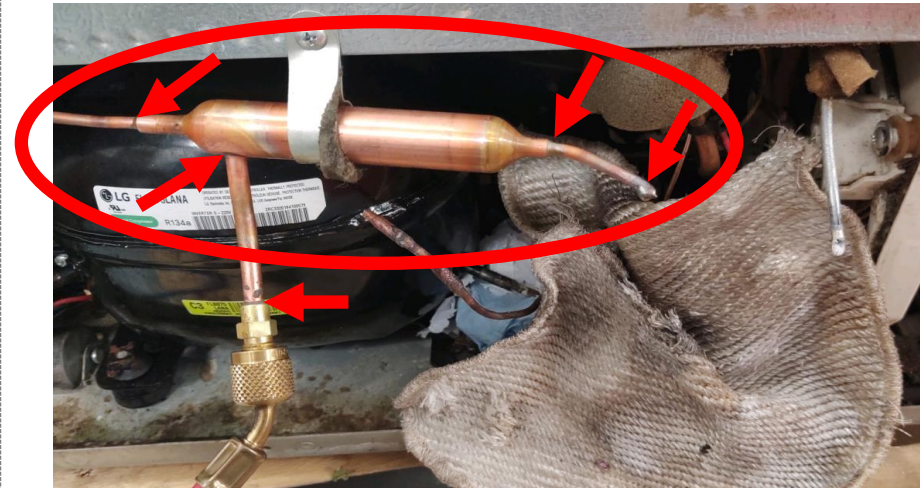
Right side are examples of improper isolations that need the driers and factory connection points removed because they sometimes leak and will trick you into thinking the yoder is bad. The goal is to eliminate all possible leak points outside of the yoder loop.

Above Example shows multiple potential leak points and why the drier needs to be removed for testing

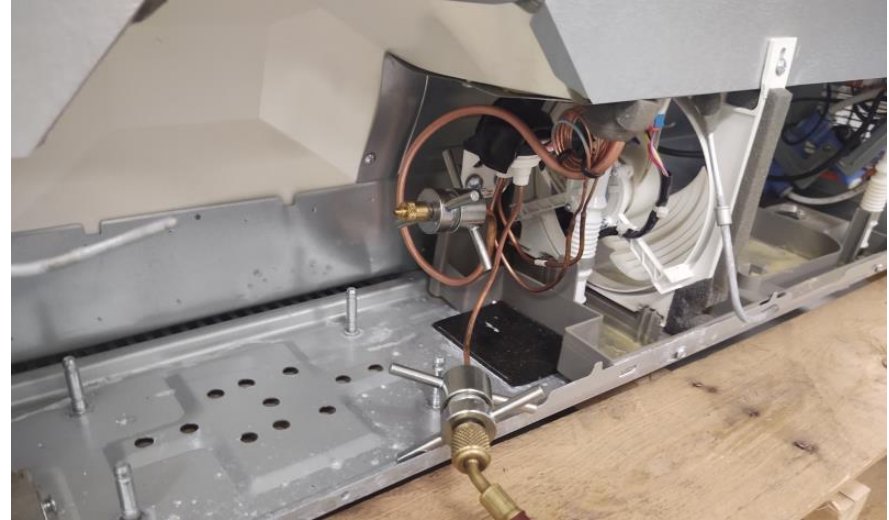
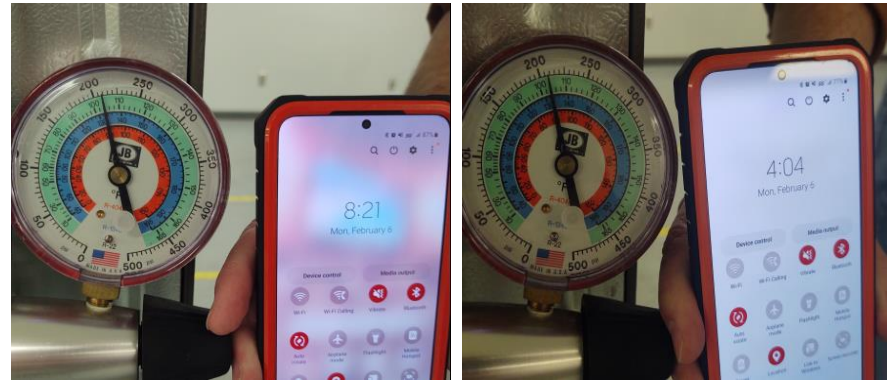
### Evaluators Findings

Also tested the low side of the system and there was no pressure drop there either.

**The leak was likely in the condenser or drier or at a high side joint. I cannot test those parts as they were removed before the unit was shipped back.**

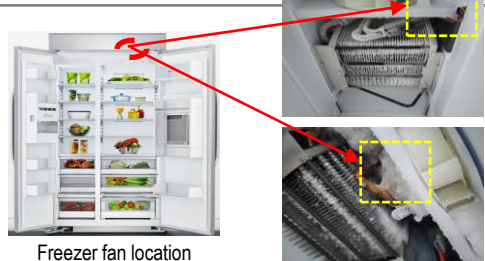
Symptoms	Ice crushing noise such as 'cracking' inside the freezer upper duct multi	<p data-bbox="1246 629 1335 658">Picture</p>

<p data-bbox="1373 735 1590 782">Freezer fan location (inside Freezer Duct, Multi)</p> <p data-bbox="1676 762 1818 809">Freezer fan motor icing defect</p>
Cause	<ul style="list-style-type: none"> <li>- If the drain caps are not installed or if they are deformed, outside humid air flows into the lower side of the Eva, causing fan freezing.</li> <li>- When the freezer door is opened, outside humid air enters and penetrates the insufficiently sealed area of the duct multi top.</li> </ul>

- Check and replace the defrost water drain cap (freezer/refrigerator) at the bottom of the refrigerator.
  - If the Drain Cap [MBL68694701 \(SVC Loc. 630B\)](#) 2 EA is not assembled, remove the product from the cabinet and assemble it from the rear.
- Remove the duct multi at the top of the freezer & check for frost around the fan motor. If icing occurs, remove icing & check the operation of the fan motor.
  - If fan motor operation is abnormal or noise occurs, replace the fan motor [AHV73129804 \(SVC Loc. 137B\)](#) and duct multi [ADJ73232401 \(SVC Loc. 135B\)](#) together.
  - If there is no problem, replace the duct multi only.

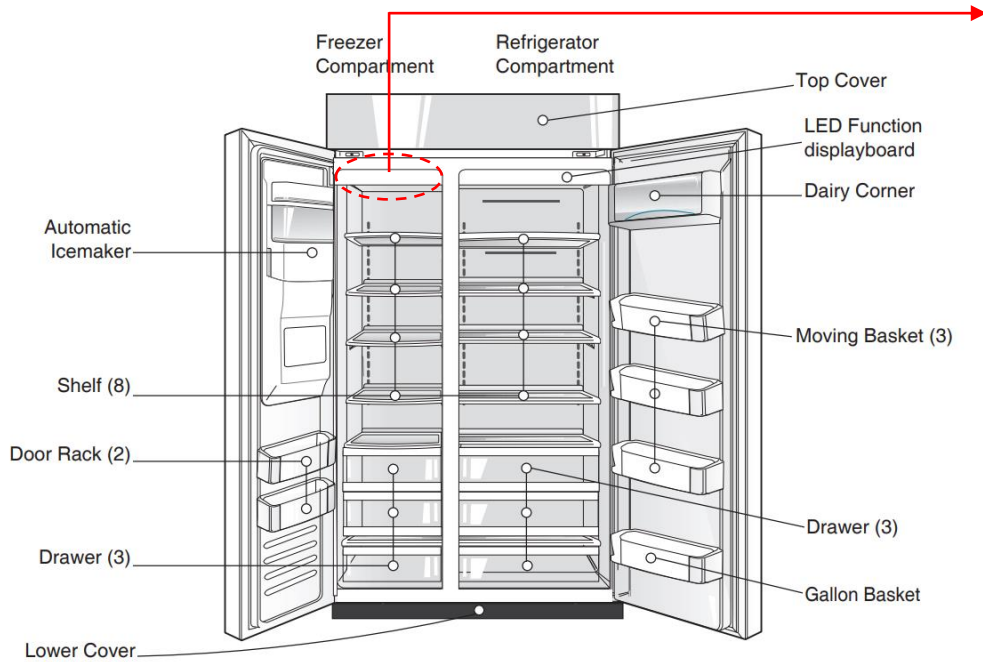
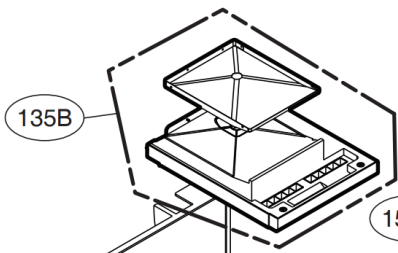
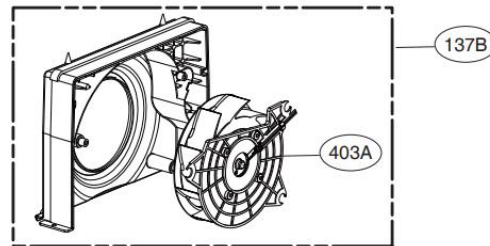
After disassembling the Duct Multi Top, check for ice formation around the fan motor.  
 If icing is found, remove it and check the operation of the fan motor.  
 In case of abnormal fan motor operation, replace the motor. P/No. AHV73129804 (SVC Loc.137B)

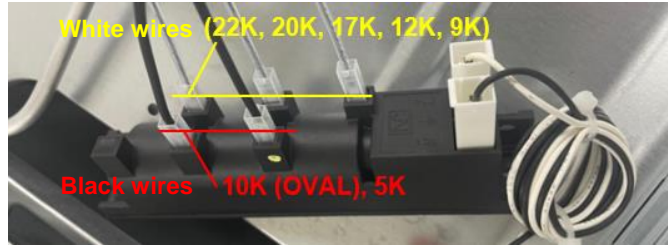
<b>Symptoms</b>	- Top burner not ignite	<b>Picture</b>

<b>Cause</b>	- Not enough Spark energy

Need to replace Transformer Assembly, Power, Cable Assembly please service as follows
