# Technical Booklet

**LG Electronics Alabama, Inc.**  
**2023. 10**

# Refrigerator SVC Bulletins

## Frost around freezer fan motor

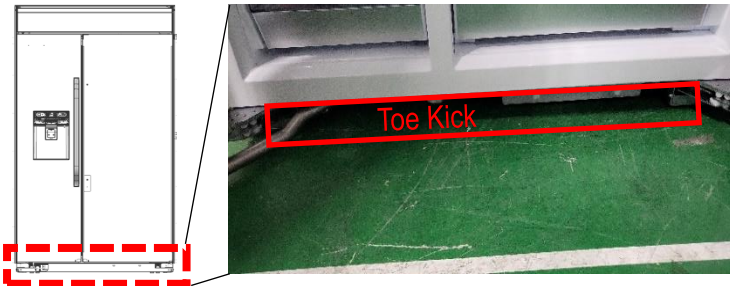
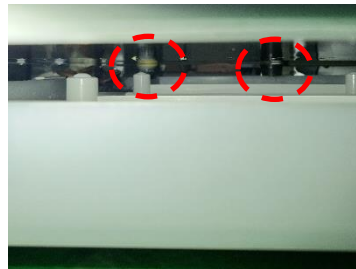
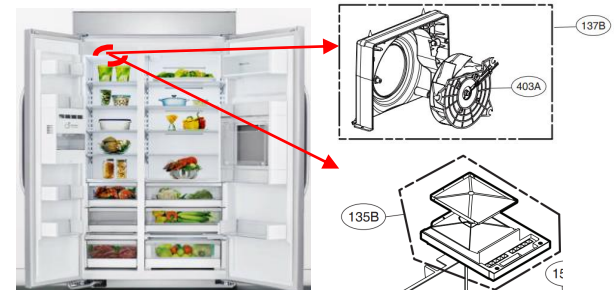
<p data-bbox="1373 735 1590 782">Freezer fan location (inside Freezer Duct, Multi)</p> <p data-bbox="1676 762 1818 809">Freezer fan motor icing defect</p>
Cause	<ul style="list-style-type: none"> <li>- If the drain caps are not installed or if they are deformed, outside humid air flows into the lower side of the Eva, causing fan freezing.</li> <li>- When the freezer door is opened, outside humid air enters and penetrates the insufficiently sealed area of the duct multi top.</li> </ul>

- Check and replace the defrost water drain cap (freezer/refrigerator) at the bottom of the refrigerator.
  - If the Drain Cap [MBL68694701 \(SVC Loc. 630B\)](#) 2 EA is not assembled, remove the product from the cabinet and assemble it from the rear.
- Remove the duct multi at the top of the freezer & check for frost around the fan motor. If icing occurs, remove icing & check the operation of the fan motor.
  - If fan motor operation is abnormal or noise occurs, replace the fan motor [AHV73129804 \(SVC Loc. 137B\)](#) and duct multi [ADJ73232401 \(SVC Loc. 135B\)](#) together.
  - If there is no problem, replace the duct multi only.

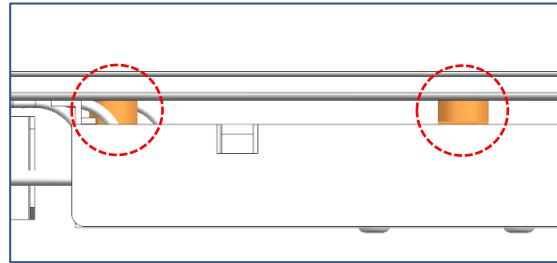
Check the presence/absence of the drain cap at the location marked in orange  
→ The drain cap is black rubber.  
→ Without the drain cap, only the white pipe is visible.

If there is no drain cap when checking from the front, un-install the product from the cabinet and install the drain cap to the pipes from the rear of the product (two marked places)
